Survey Report on
2015 Floods

မတ်လ (၂၀၁၆) ခုနှစ် March 2016

The Project on Establishment of
End-to-End Early Warning System
for Natural Disaster

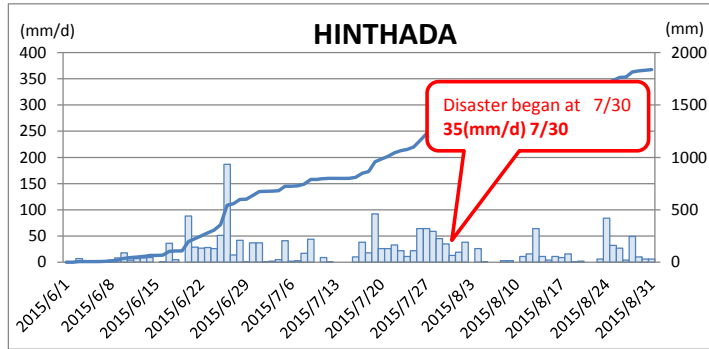
Ayeyarwady Region is located downstream of the Ayeyarwady River basin. The water level reached the danger level at the end of July at Hinthada station, and the disaster was reported almost at the same time. According to the interview survey carried out separately, the disaster was not due to the riverine flood from Ayeyarwady River, but due to the runoff from the western mountain area. It can be said that the runoff from the western mountain area could not flow into the Ayeyarwady River because of the high water level of the river. Figure 4-14 shows that the rainfall amount and the water level have no correlation, indicating that the water level was greatly affected by the runoff volume from the upper catchment.

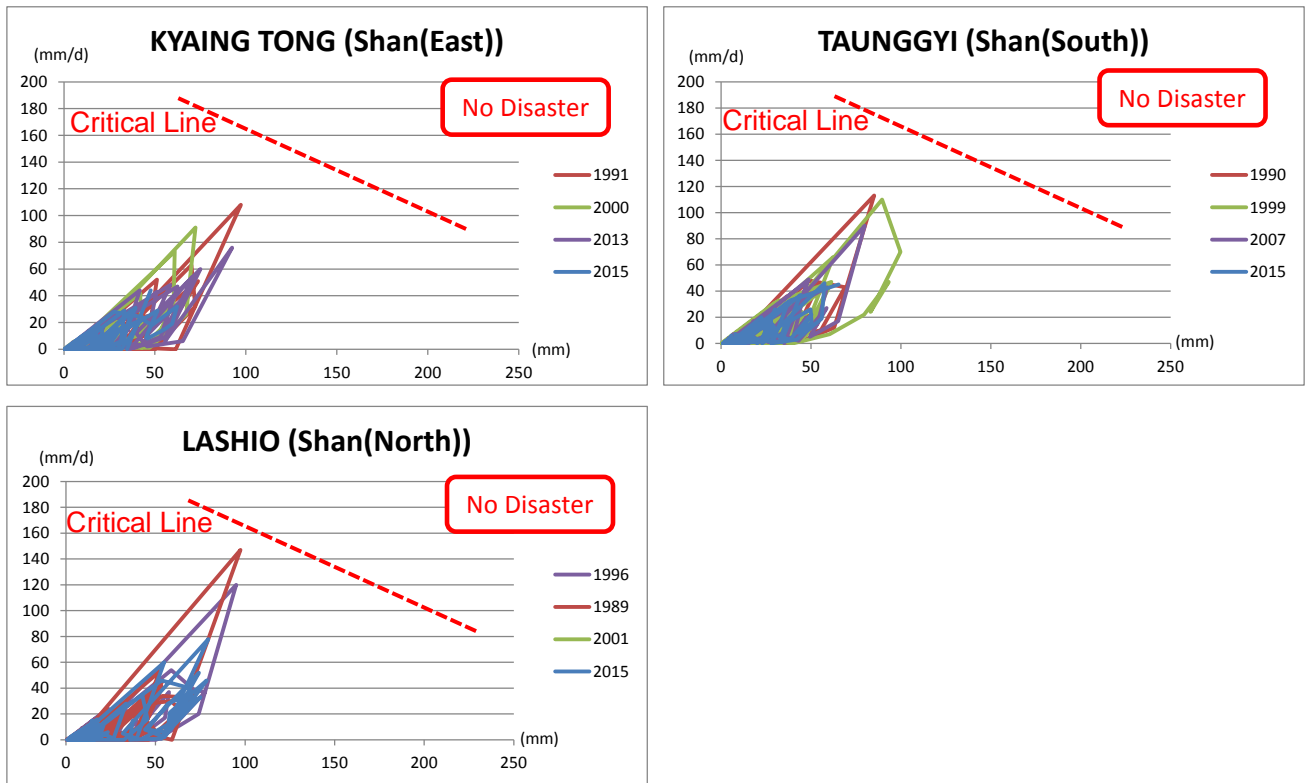
The snake line was calculated and drawn using the daily rainfall data in Shan State. Since there has been no record of landslides including the 2015 floods in Shan State, the critical line should be outside of the snake lines. More data and information is required for an estimation of the critical line.

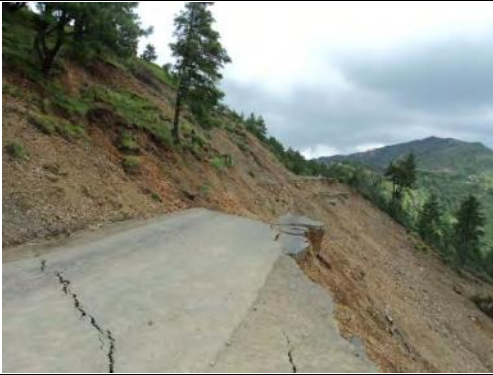
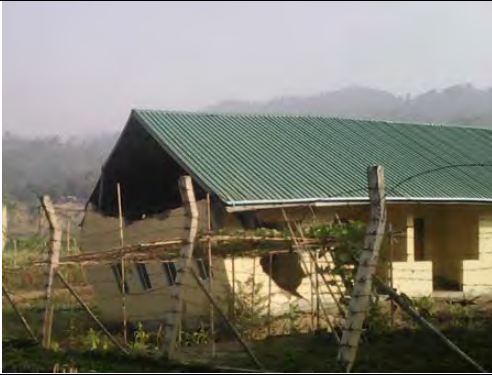
One way road when landslide occurred	Broke by flash waters in Pa LatWa
